RE: Progress report for October 2009 activities - Hecla Mining Company Apex Site
(EPA ID No. UT982589848, Docket No. RCRA-8-99-06)

SUBJECT: Progress Report No. 66 for period ending October 31, 2009; Pond 2 Final Closure - Apex Site, Washington County, Utah

TO: Paul Glader (Hecla Mining Company)
FROM: Doug Gibbs (Monster Engineering Inc.)
DATE: 10/19/09
SUBJECT: **Surface Monument Survey Data Review – Apex Site**

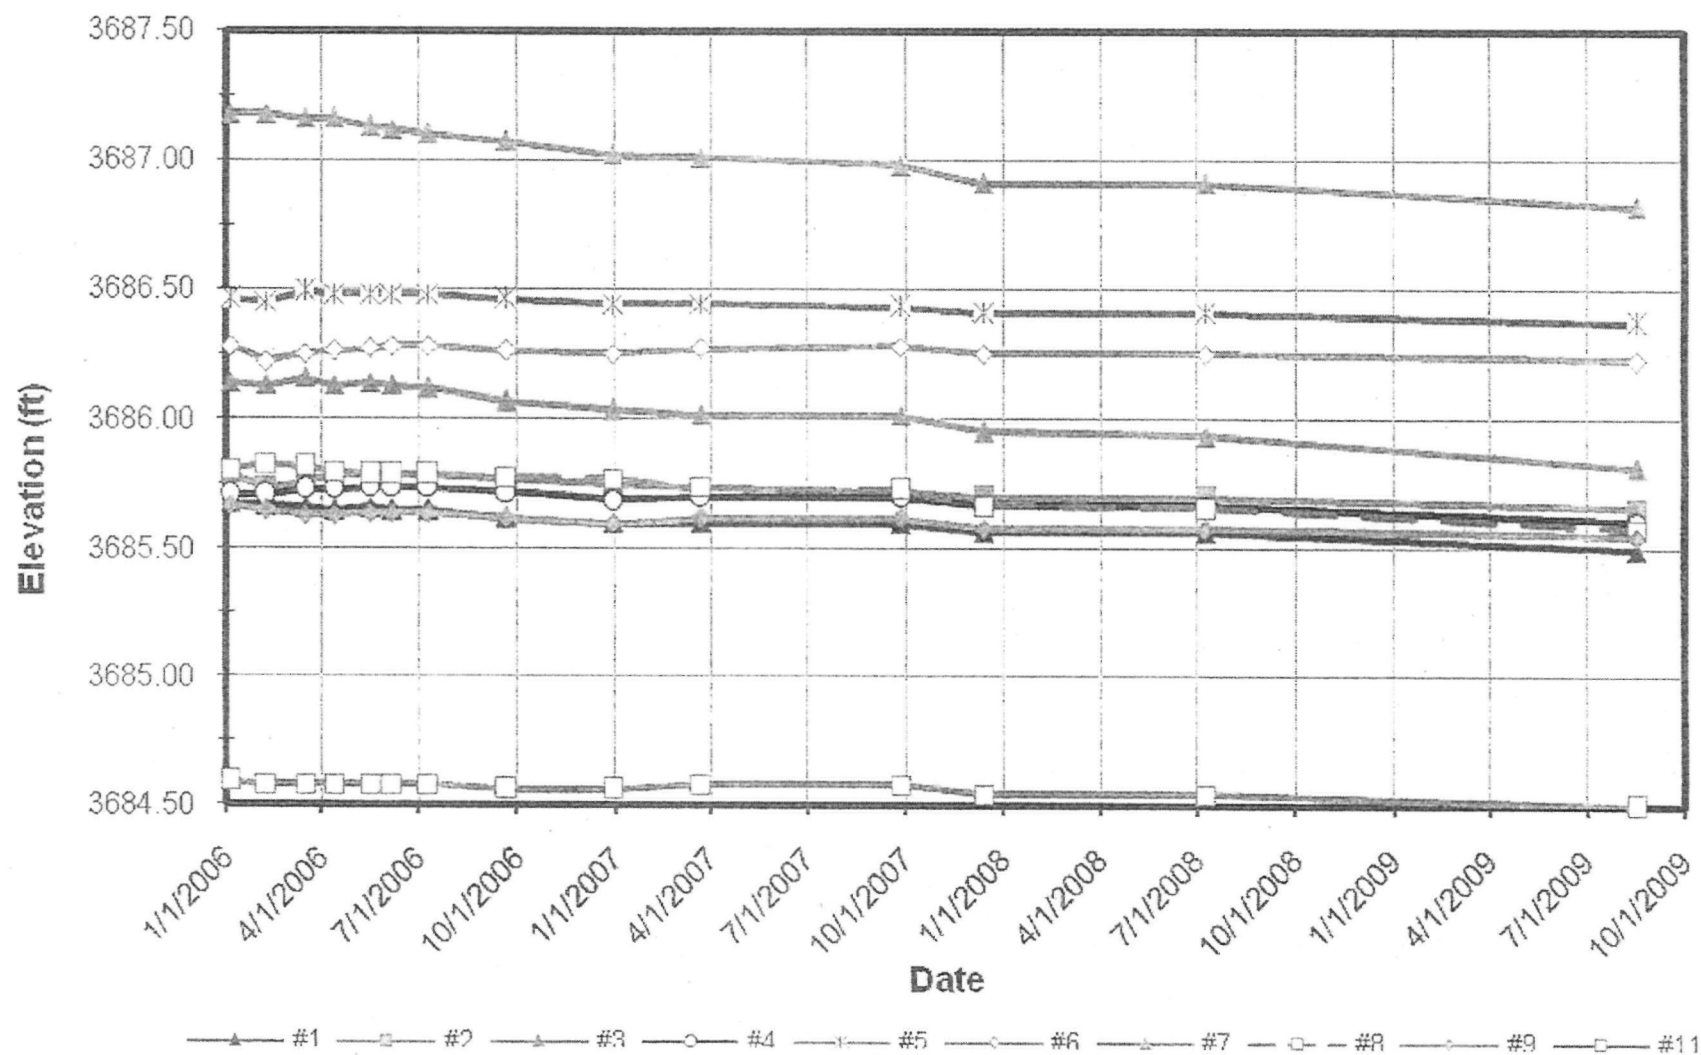
Apex Pond 2 - Settlement Monument Elevations

All elevation data provided by Alpha Engineering is presented graphically on the following pages. The first graph shows all monuments (except monitor #10 the baseline point) on a scale that allows all data to be compared. The next five graphs have expanded "Y" axes scales in order to more clearly show elevation changes, and for ease of comparison between graphs. A monument location map (provided by Alpha Engineering) is attached on the last page of this document. Included on this map are contours showing approximate total settlement of the top surface since installation of the monuments.
